## HOLDEN MINE REMEDIATION PROJECT

### Holden Mine Remediation construction update for May 2014:

### Holden Mine Remediation construction update for June 2014:

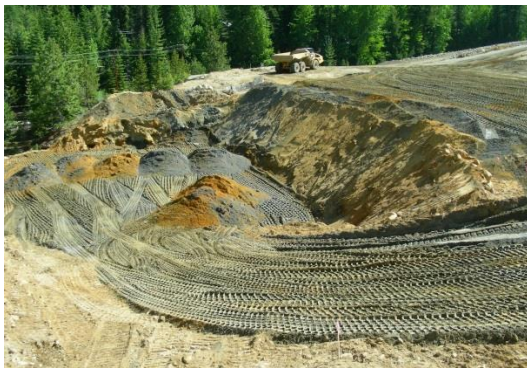
Backfilling the northwest corner of tailings pile 1 following sawdust pile removal

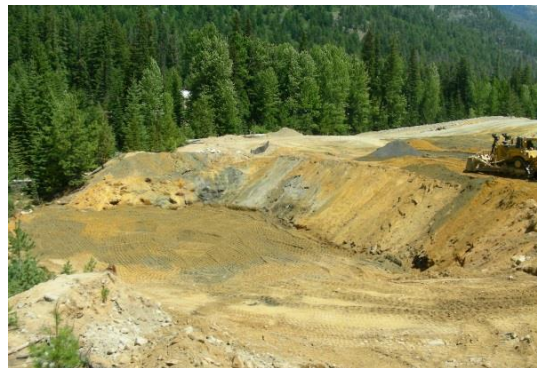
Compacting the northwest corner of tailings pile 1 following sawdust pile removal

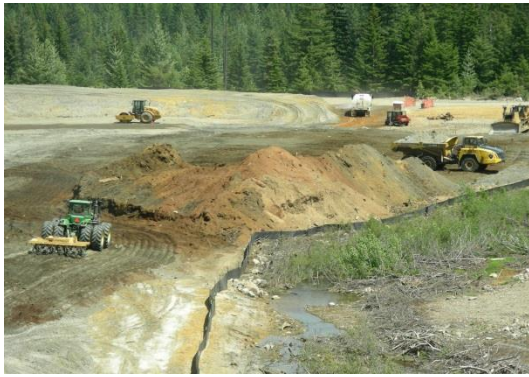
Tractor and disc used to incorporate layer-placed sawdust from Tailings Pile -1 into Tailings Pile -3

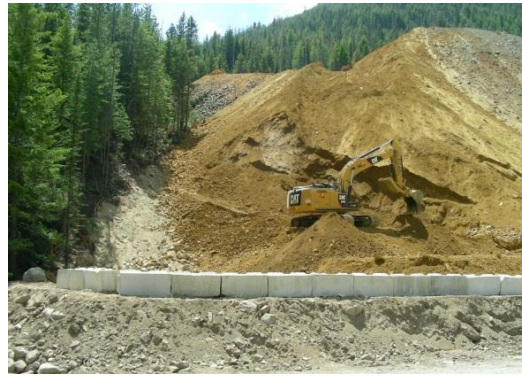
Excavation at the toe of the East Waste Rock pile for use as borrow for tailings stabilization

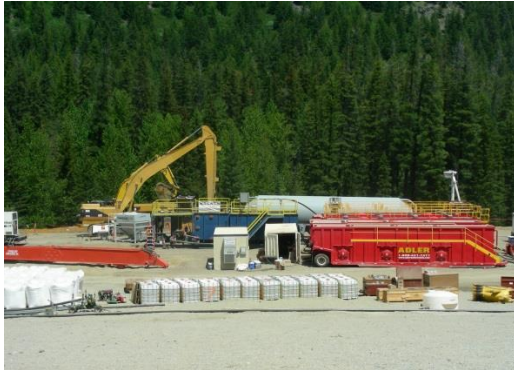
Slurry batch plant and stockpiled materials at tailings pile 1

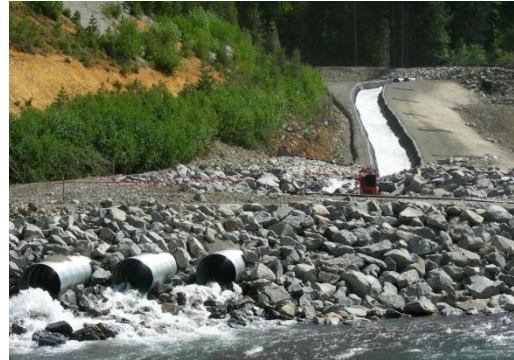
East Copper Creek diversion entering Railroad Creek

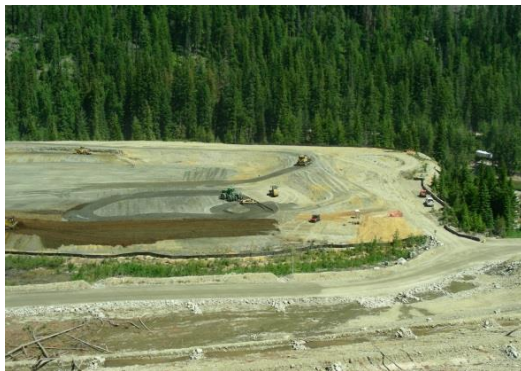
Tailings and sawdust placement on east tailings pile 3

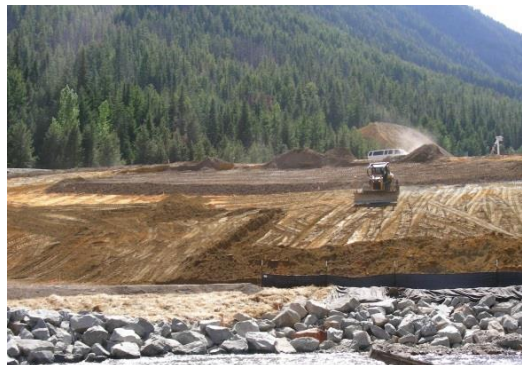
Final grading and temporary cover at northeast tailings pile 1

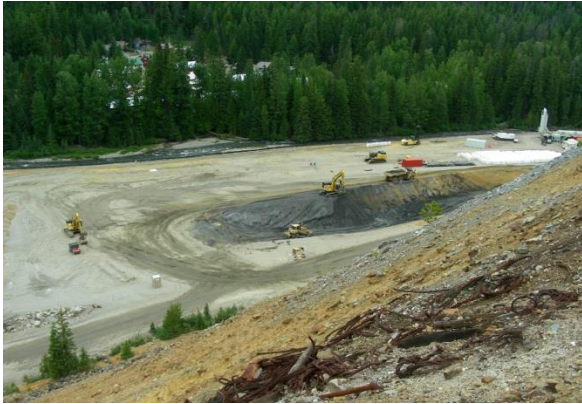
Grading at tailings pile 1

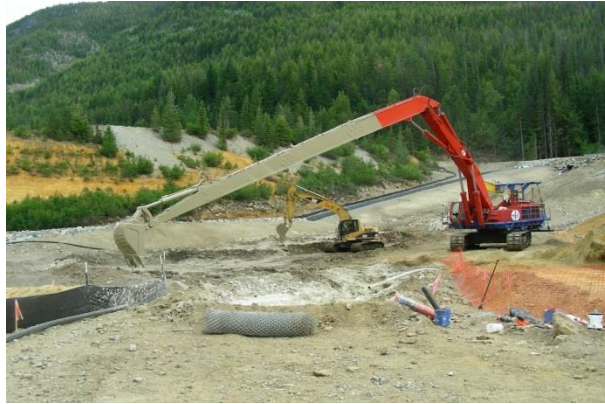
Digging the first barrier wall panel at east Copper Creek wing wall. Note the difference in the size of the two machines!

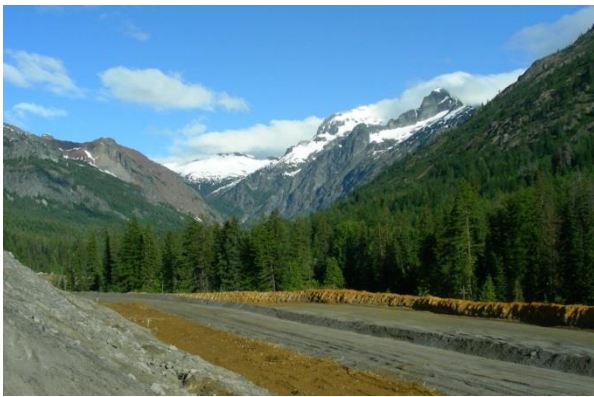
East waste rock pile material used for buttressing the slimes layer on tailings pile 2

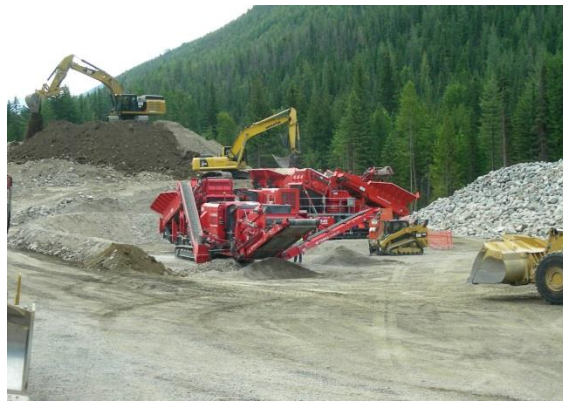
Sorting and crushing operations

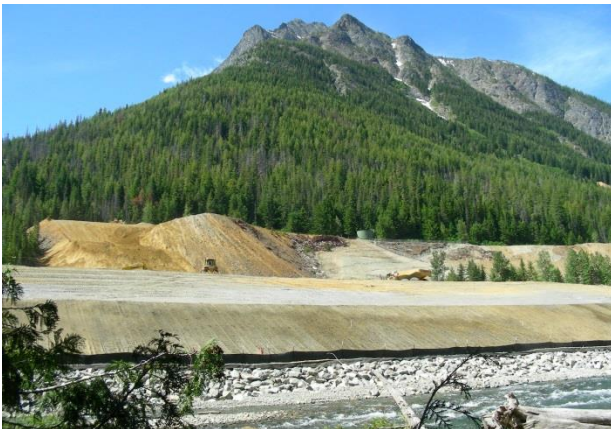
Tailings pile 1 graded slopes in foreground, east waste rock pile borrow for slimes buttress in the background

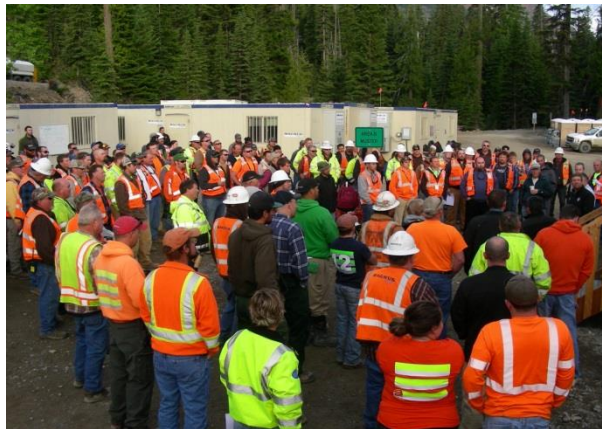
Over 155 workers are now on-site
